TECHNICAL NOTE 3512

EFFECT OF SOME SELECTED HEAT TREATMENTS ON THE
OPERATING LIFE OF CAST HS-21 TURBINE BLADES

By Francis J. Clauss, Floyd B. Garrett, and
John W. Weeton

Lewis Flight Propulsion Laboratory
Cleveland, Ohio

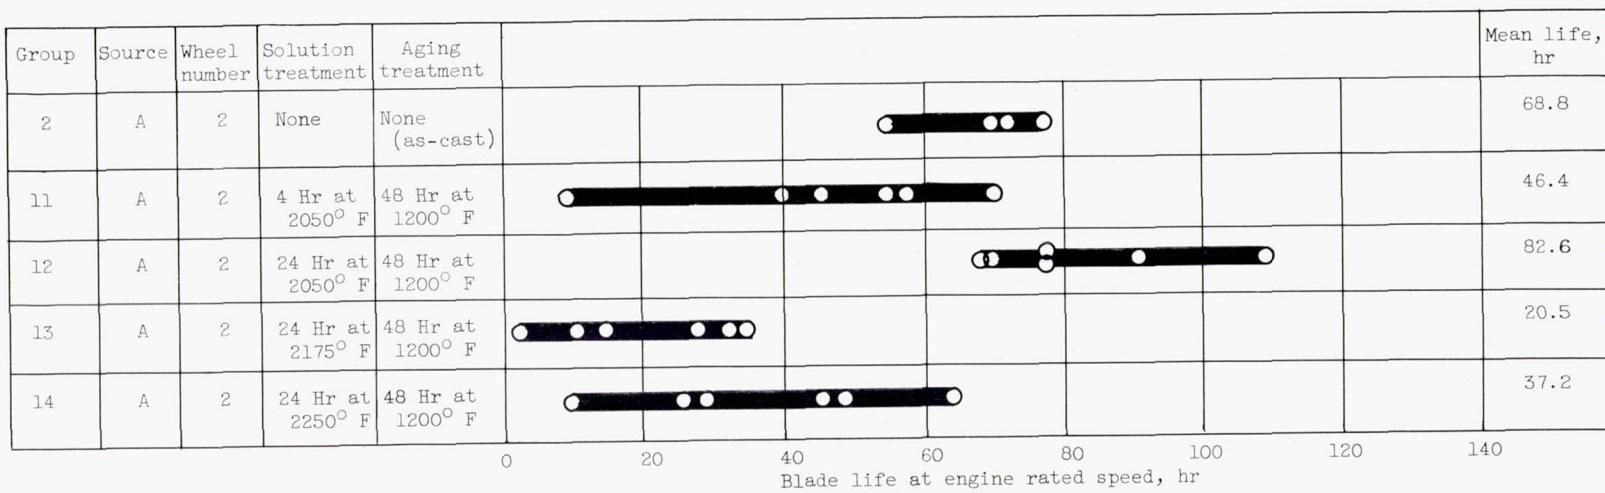
Figure 5. - Effect of various solution treatments before aging 48 hours at 1200° F.

The effect of various solution treatments followed by aging 48 hours at 1200° F is shown in figure 5. These treatments (groups 11 to 14) did not improve the performance as expected from the study of stress-rupture life on wrought material (ref. 7). Of the various solution treatments used before aging at 1200° F, only 24 hours at 2050° F (group 12) gave a better mean life than that of the as-cast blades (group 2). This improvement was only slight and less than could be obtained by other heat treatments.

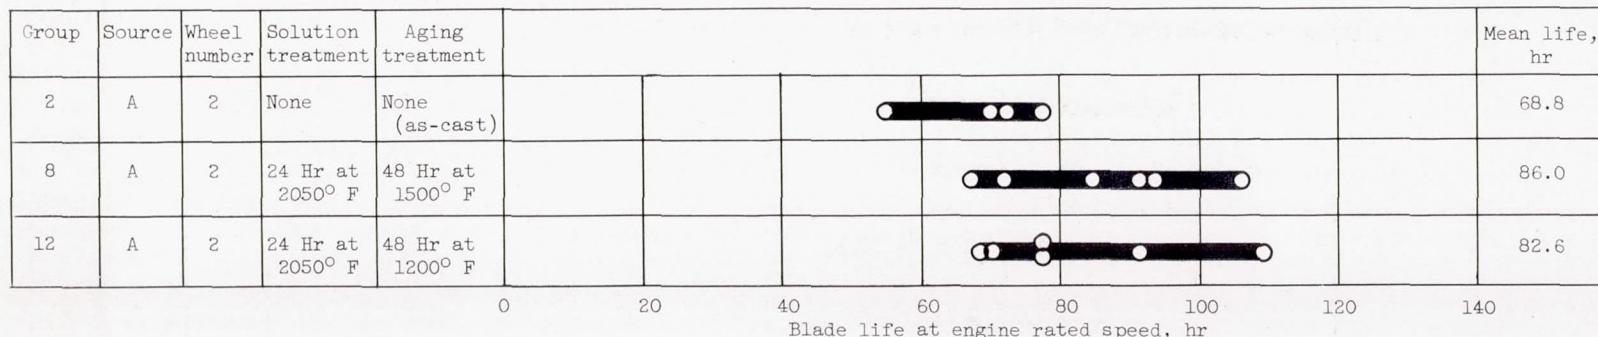
Figure 6. - Comparison of aging at 1500° and 1200° F after solution treatment.

Aging temperatures of 1200° and 1500° F did not give much difference in the results, as can be seen by comparing groups 8 and 12 in figure 6. In both of these groups, solution treatment was 24 hours at 2050° F before aging for 48 hours at 1500° and 1200° F. For other solution treatments, aging at 1200° F might have produced differences.

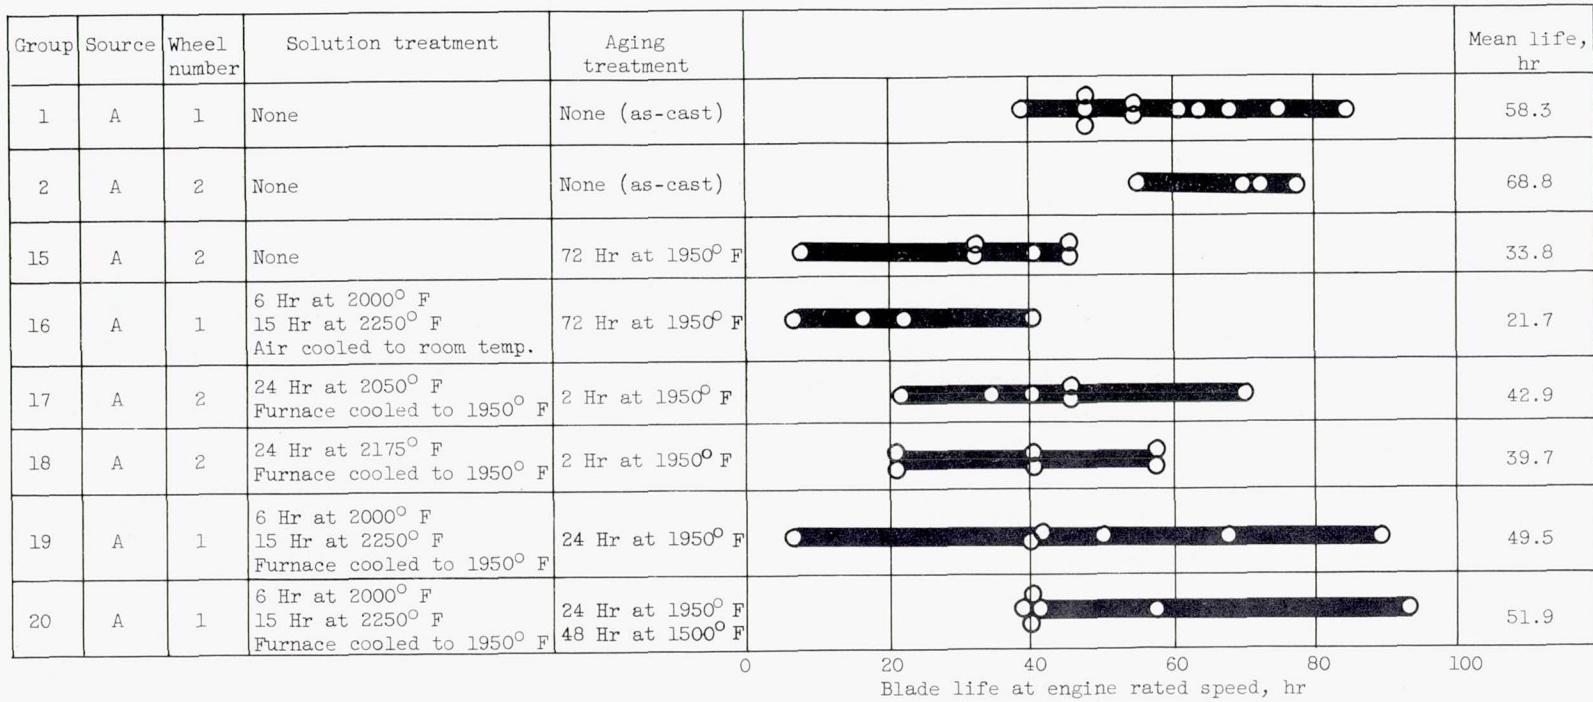
Figure 7. - Effect of aging or isothermal transformation at 1950° F.

All blades aged or transformed at 1950° F performed poorer than the as-cast blades, as shown in figure 7. This was true whether the blades were aged alone (group 15) or were solution treated and aged (group 16). Furnace cooling and aging at 1950° F following solution treatment was also unsuccessful (groups 17 to 19). Aging at 1500° F after furnace cooling and aging at 1950° F (group 20) recovered some of the strength, but the performance was still poorer than that of the as-cast blades.

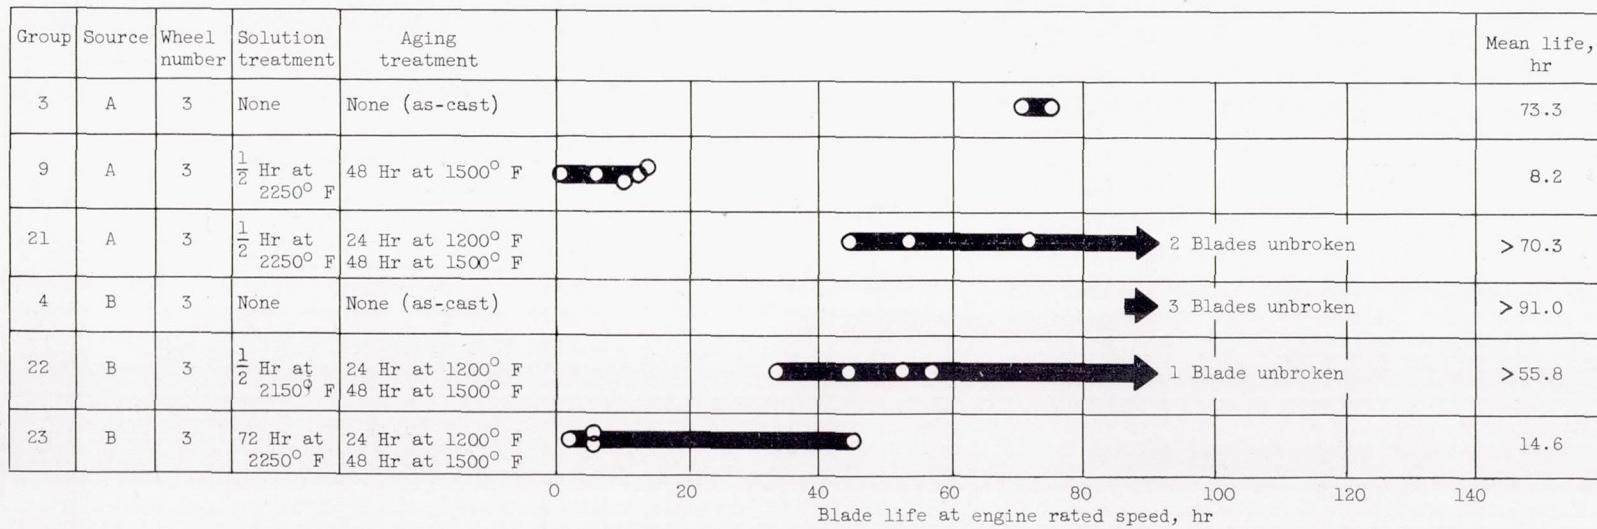
Figure 8. - Effect of double-aging heat treatments.

Double aging (fig. 8). - Double-aging treatments, in which blades were solution treated and aged 24 hours at 1200° F plus 48 hours at 1500° F (groups 21 to 23) failed to increase blade life. None of the groups showed a significant improvement in performance over that of the as-cast condition. Note that double aging after 1/2 hour at 2250° F (group 21) greatly increased the performance over that of the same solution treatment followed by a single age at 1500° F (group 9). The long-time solution treatment used in group 23 gave the poorest results of the double-aged groups.

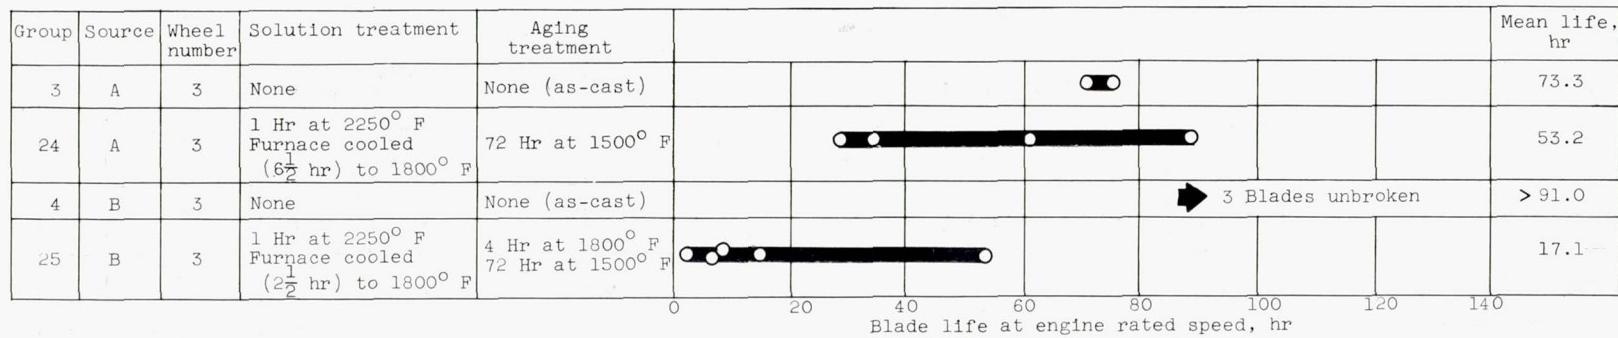
Figure 9. - Effect of treatment described in reference 3.

Treatment of reference 3 (fig. 9). - The heat treatment which was most successful in improving blade performance in the type B turbosupercharger (ref. 3) did not improve the life of the J33 jet engine turbine blades of cast HS-21. Blades given this heat treatment (groups 24 and 25) were poorer than the as-cast blades.

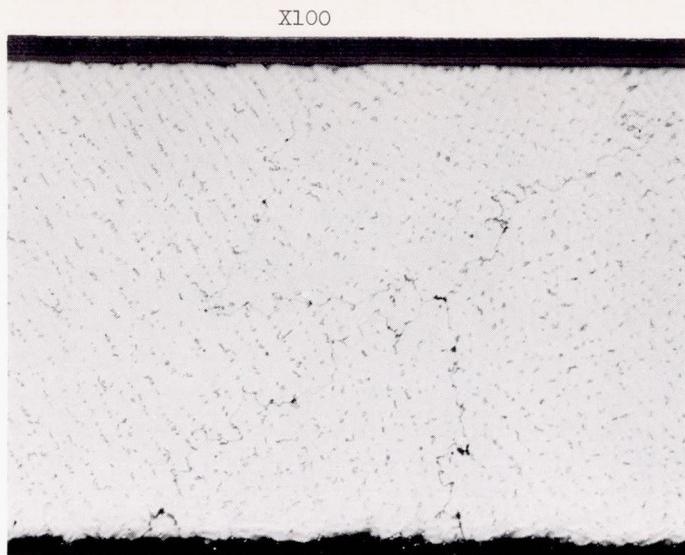
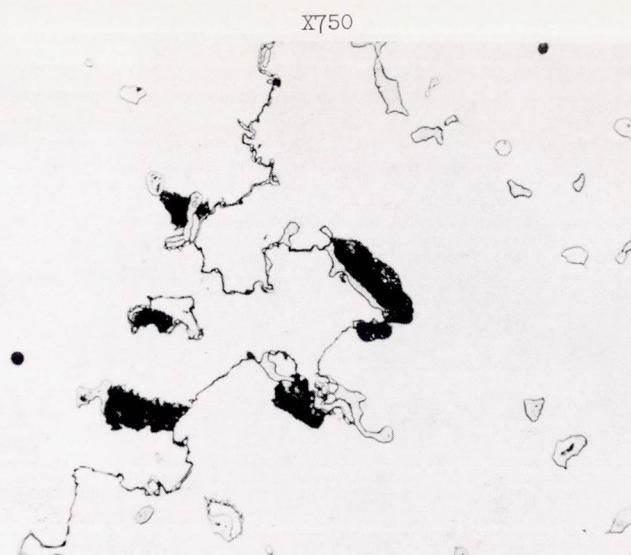
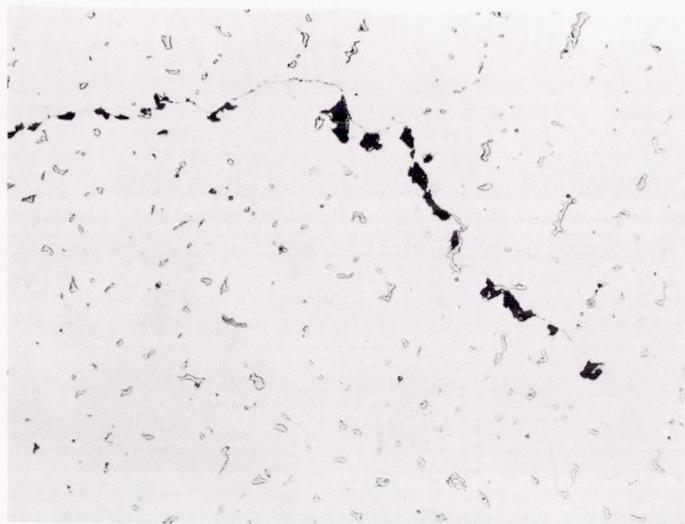
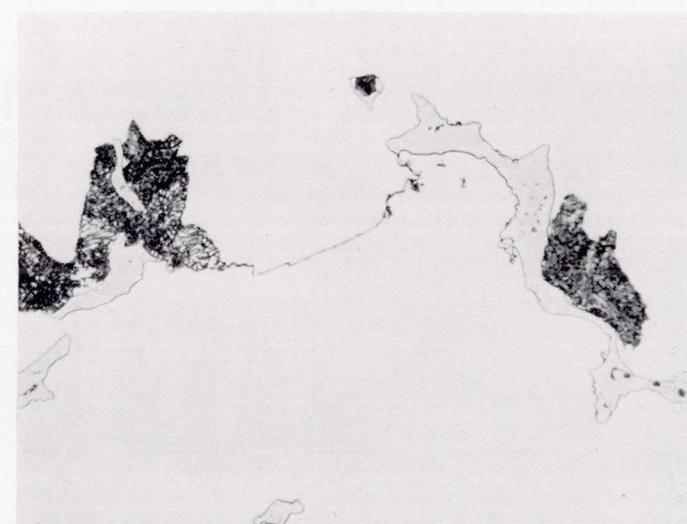
As-cast structure. - Photomicrographs of cast blades from both sources are presented in figures 10 and 11. Dendritic segregation, typical of cast materials, was present in all the blades. Carbides were precipitated both as small, irregular islands and as a lamellar formation resembling pearlite. The carbide islands were generally distributed through the interior of the grains, where both their size and the distance between them tended to increase as the section size increased (e.g., in going from the trailing tip at the top of the blade to the midchord at the base). Pearlite, when present, was generally located in small patches along grain boundaries. Occasionally, areas in blades from both sources were observed which had an especially heavy concentration of pearlite precipitate, such as shown in figure 11(c). While there were noticeable variations in the microstructure of the as-cast blades from the same source, there was also a general tendency of the blades from source B to contain more pearlite than those from source A. The interdendritic eutectic areas also appeared larger in the blades from source B. The grain size of all blades was predominately macroscopic, considerably larger than A.S.T.M. 1.

Figure 10. - Microstructure of cast HS-21 turbine blades from source A in as-cast condition (groups 1 to 3).
Electrolytically etched in 5 percent aqua regia.

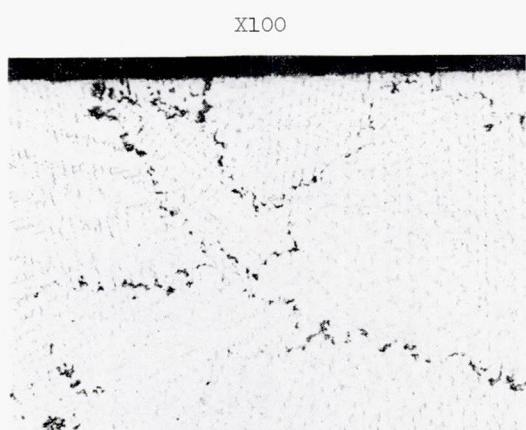
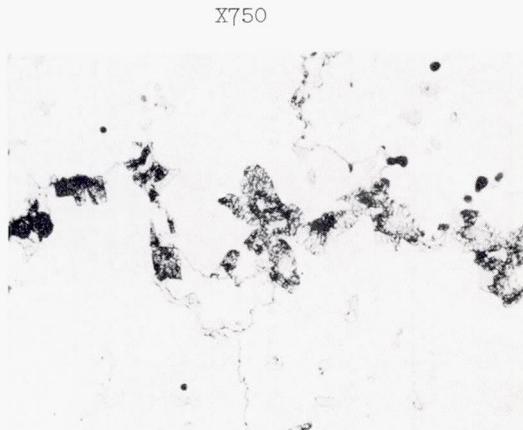
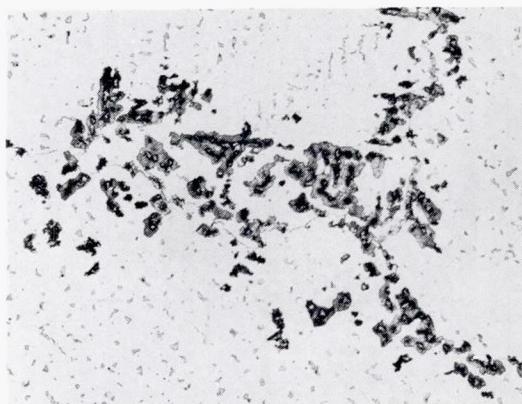
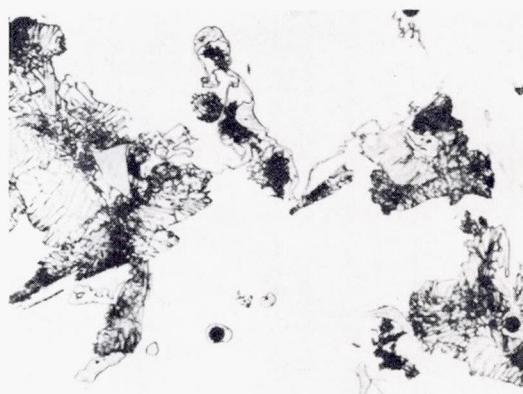
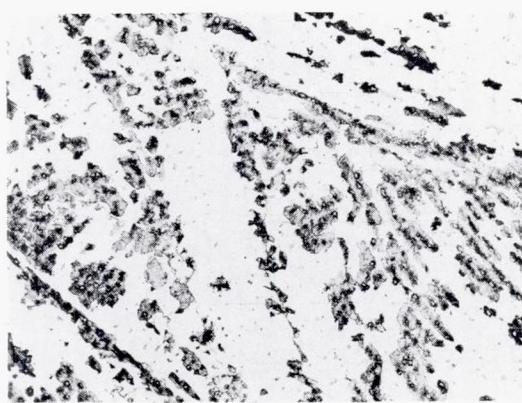
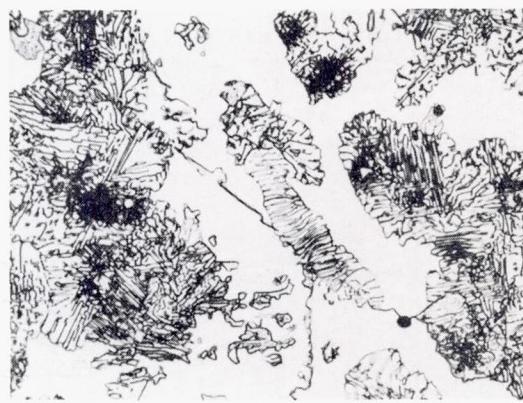
Figure 11. - Microstructure of cast HS-21 turbine blades from source B in as-cast condition (group 4). Electrolytically etched in 5 percent aqua regia.

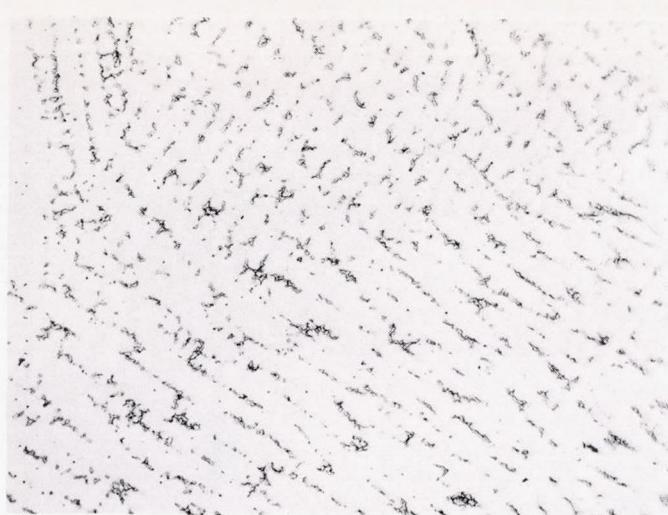
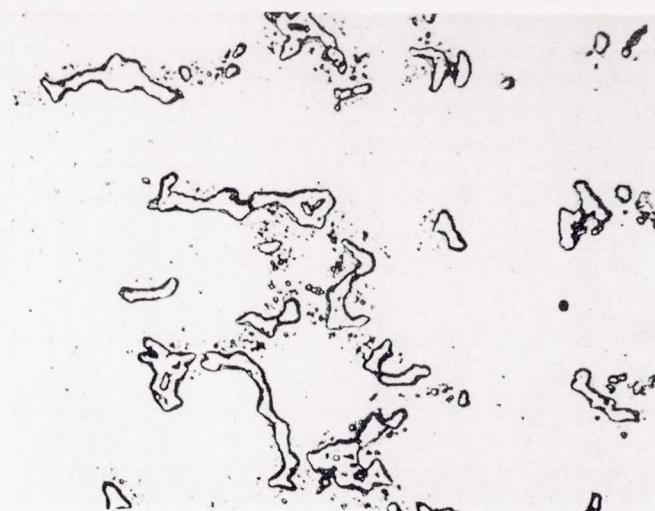
Solution treating. - The degree of solution treatment obtained by holding the cast blades at temperatures of 2050° F and above is shown in figures 12 and 13. Four hours at 2050° F was found to be insufficient to dissolve all the carbides into the matrix (figs. 12(a) and 13(a)). Increasing the time and temperature to 24 hours and 2175° F, respectively (figs. 12(b) and 13(b)), dissolves more of the carbides, particularly with blades from source A. However, it also results in an increase in the number and severity of the partial voids which probably are due to eutectic melting. These voids occur in areas formerly occupied by interdendritic carbides. After 24 hours at 2250° F, solution of the carbides is complete, but the occurrence of eutectic melting is especially severe, particularly in blades from source B (fig. 13(c)). There was also some grain boundary melting in this case.

(a) 4 Hours at 2050° F.

Figure 12. - Response of cast HS-21 turbine blades from source A to solution treatment. Electrolytically etched in 5 percent aqua regia.

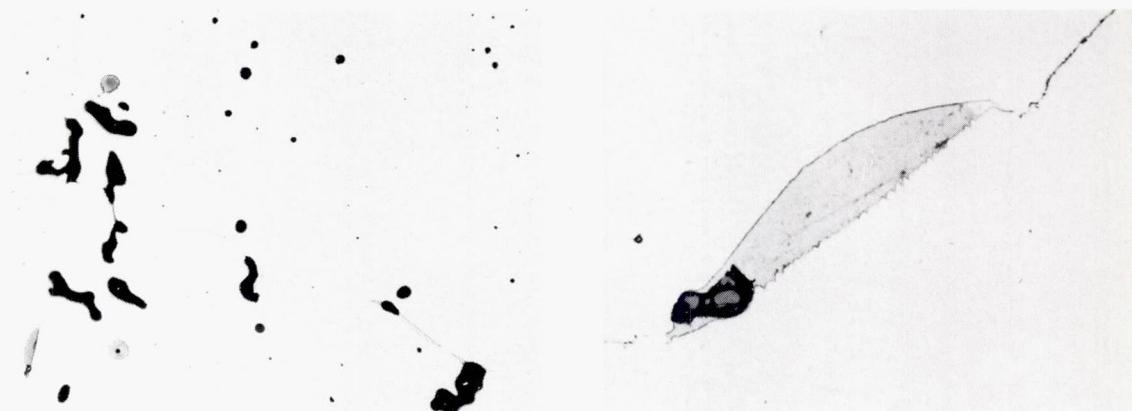
(c) 24 Hours at 2250° F.

Figure 13. - Response of cast HS-21 turbine blades from source B to solution treatment.
Electrolytically etched in 5 percent aqua regia.

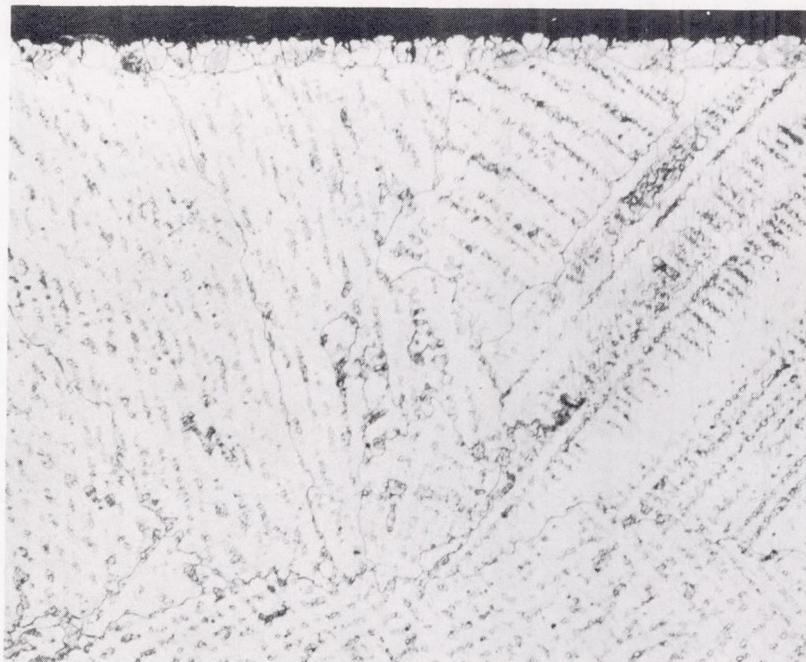
Solution treatment generally resulted in a recrystallized skin of small grains at the leading and trailing edges of the blades. An example of this in blades before operation is shown in figure 14. A decrease in the amount of carbide precipitation at the surface was noted in several cases.

Figure 14. - Recrystallized layer of small grains at edge of heat-treated blade from group 17 (solution treated 24 hr at 2050° F, furnace cooled to 1950° F, aged 2 hr at 1950° F, and air cooled). Electrolytically etched in 5 percent aqua regia.

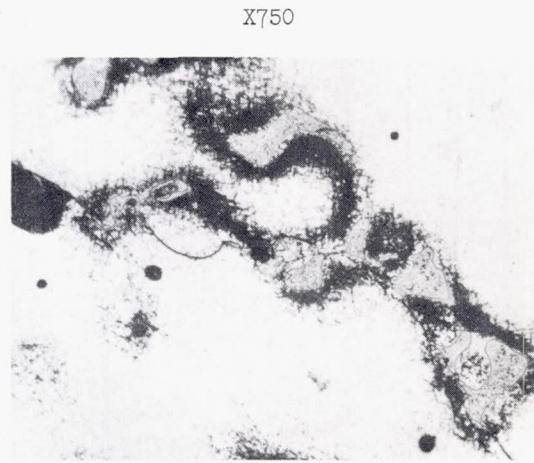
Aging and effects of prior solution treatments on aged structures. - Aging the cast blades at 1500° F resulted in the formation of fine particles of precipitate clustered about the primary carbides. This is shown in figure 15(a), for which the aging time was 48 hours. Different solution treatments followed by this same aging treatment gave the microstructures shown in figures 15(b) to (e). In general, increasing the time or temperature of solution treatment gave a wider distribution of carbide precipitation during aging at 1500° F. Figure 16 shows the microstructure after solution treatment and aging at 1200° F. Except for small patches of pearlite that are sometimes observed along the grain boundaries, aging at 1200° F has produced no apparent change in the solution-treated structure.

(a) No prior solution treatment (groups 5 and 6).

Figure 15. - Microstructure of cast HS-21 turbine blades after aging 48 hours at 1500°F .
Electrolytically etched in 5 percent aqua regia.

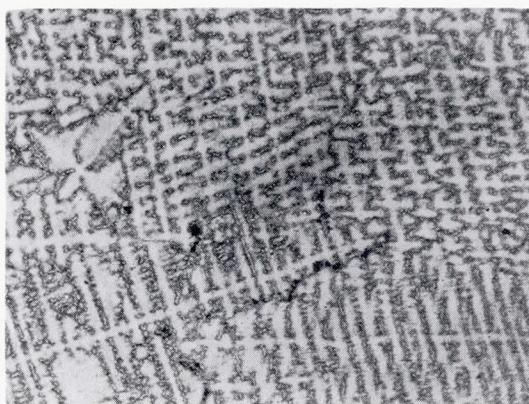
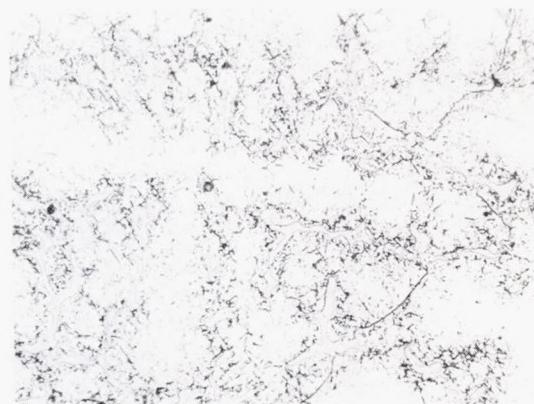
(b) Solution treated 1/2 hour at 2150°F and air cooled prior to aging (group 7).

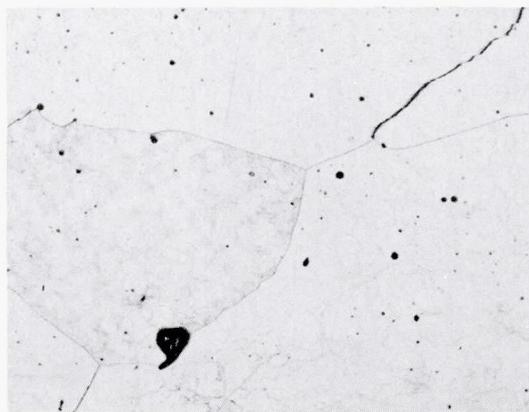
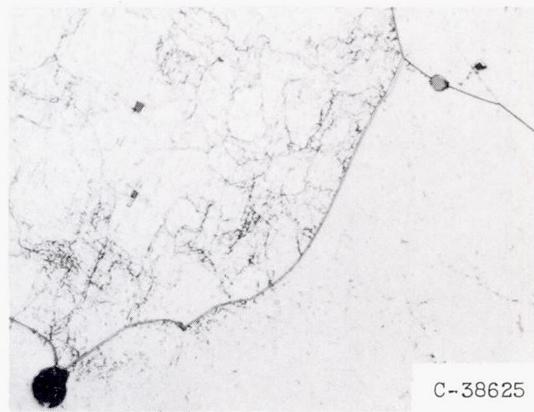
(c) Solution treated 1/2 hour at 2250°F and air cooled prior to aging (group 9).

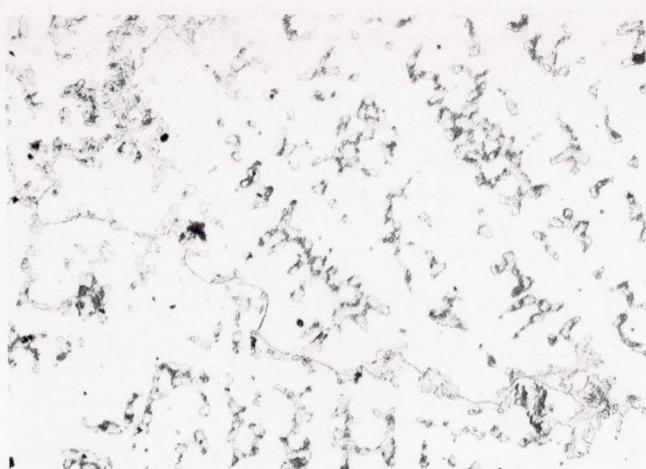
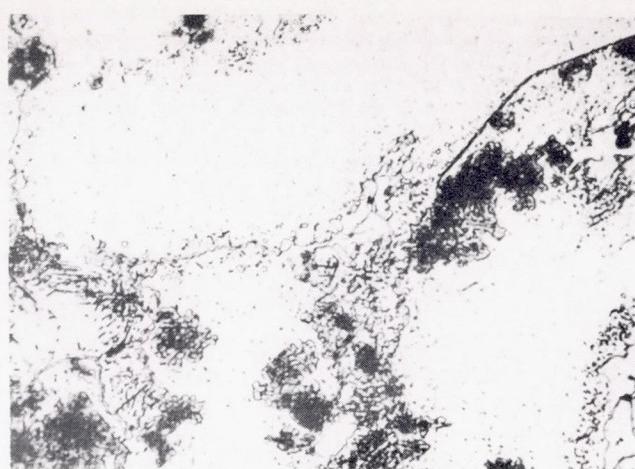
(d) Solution treated 24 hours at 2050° F and air cooled prior to aging (group 8).

Figure 15. - Concluded. Microstructure of cast HS-21 turbine blades after aging 48 hours at 1500° F. Electrolytically etched in 5 percent aqua regia.

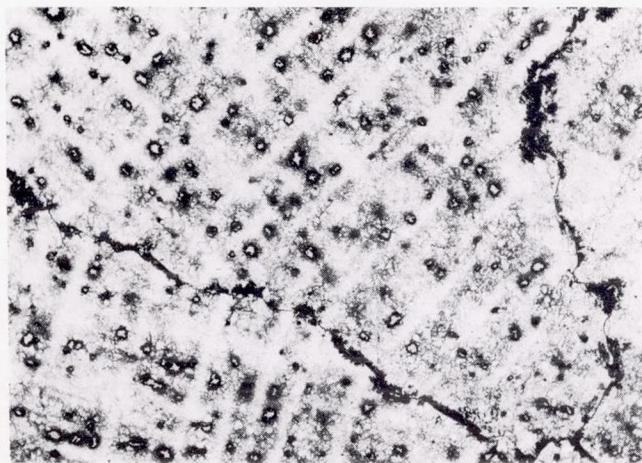
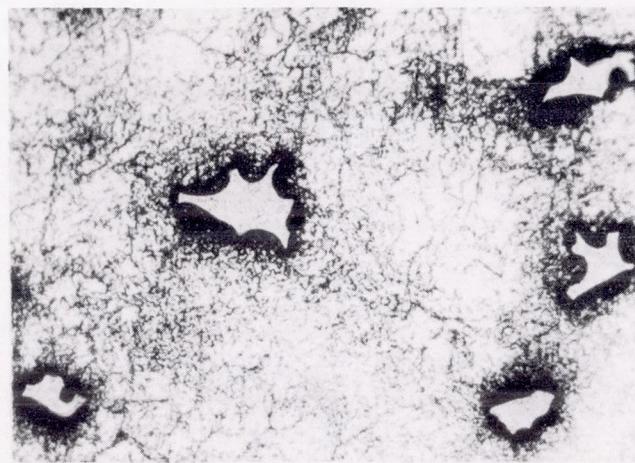
(e) Solution treated 24 hours at 2250° F and air cooled prior to aging (group 10).

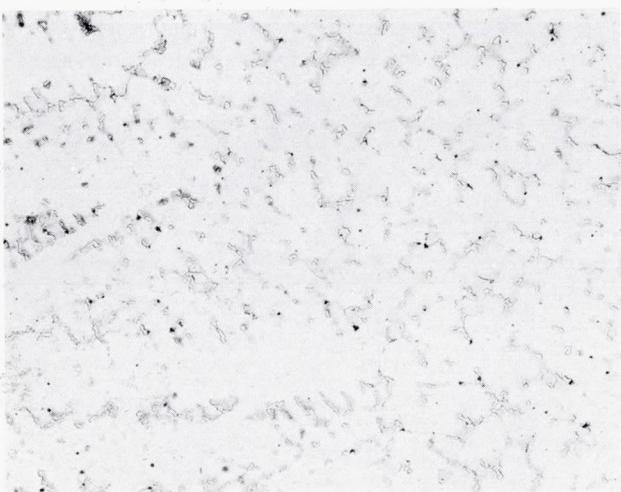
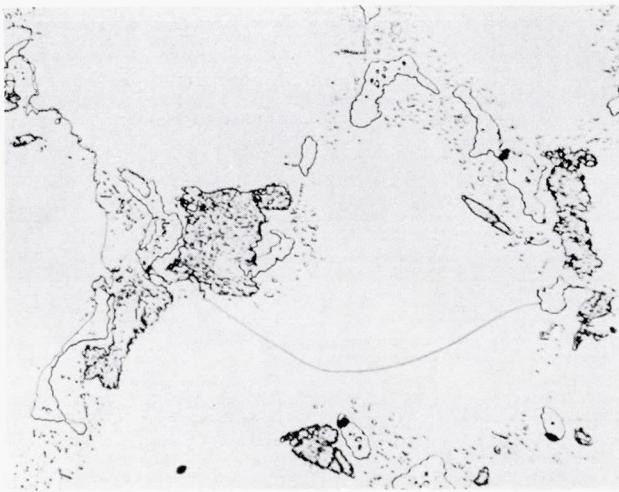
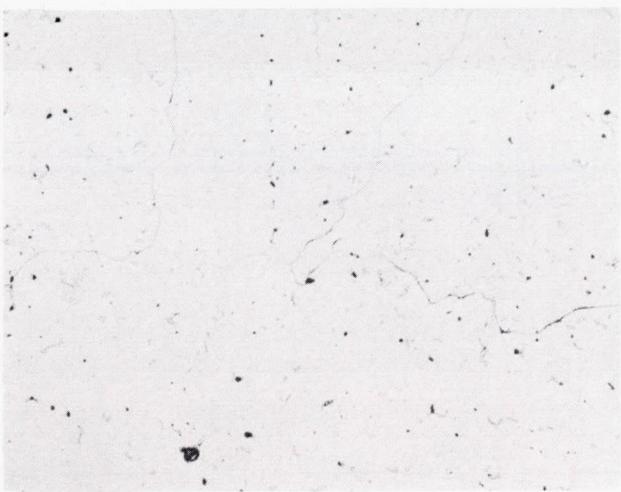
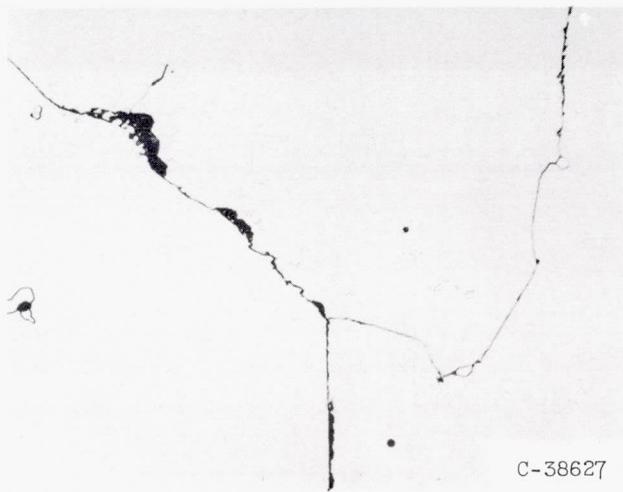
(a) Solution treated 4 hours at 2050° F and air cooled prior to aging (group 11).

(b) Solution treated 24 hours at 2175° F and air cooled prior to aging (group 14).

Figure 16. - Microstructure of cast HS-21 turbine blades after aging 48 hours at 1200° F. Electrolytically etched in 5 percent aqua regia.

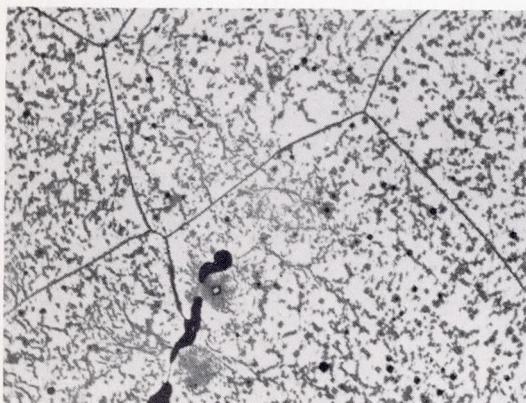
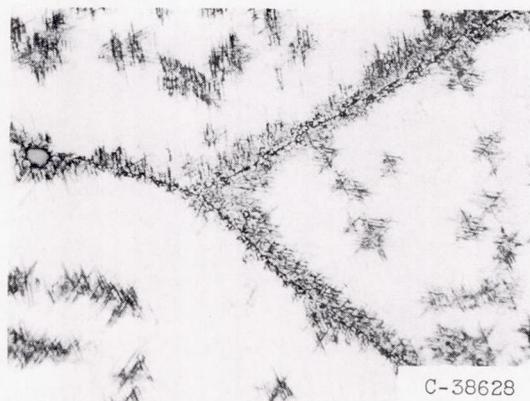
(c) Solution treated 72 hours at 2250° F and air cooled prior to aging (group 23).

The microstructures after double aging, using a 24-hour age at 1200° F between solution treating and aging at 1500° F, are shown in figure 17 for three conditions of solution treatment. One-half hour at 2250° F (fig. 17(b)) gave a wider distribution of precipitation during aging than 1 hour at 2150° F (fig. 17(a)), while 72 hours at 2250° F gave a heavy Widmanstätten type of precipitate (fig. 17(c)).

Figure 17. - Microstructure of cast HS-21 turbine blades after double aging 24 hours at 1200° F plus 48 hours at 1500° F. Electrolytically etched in 5 percent aqua regia.

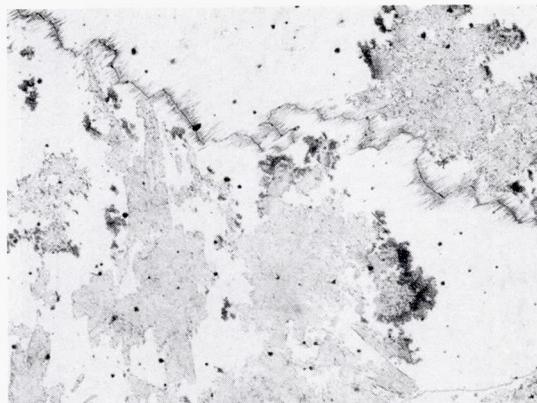
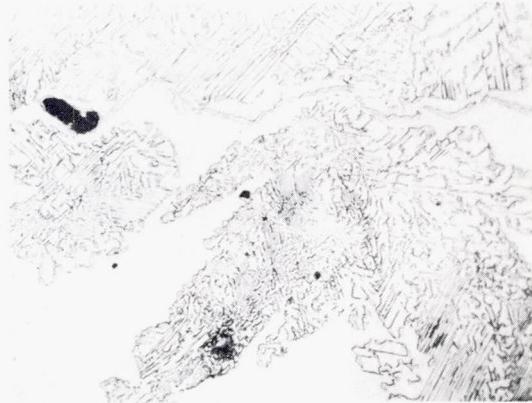
Effect of furnace cooling. - Microstructures produced in turbine blades which had been furnace cooled after solution treatment and then aged are shown in figures 19 and 20. Figure 19 (group 24) shows the microstructure for the heat treatment which gave the best operating life for type B supercharger blades (ref. 3). Carbide precipitation after this type of treatment was almost entirely in a lamellar form resembling pearlite. Blades in group 25 had an identical microstructure to these. (N.B. - Actually, both groups 24 and 25 were intended to have the same heat treatment, but, due to experimental difficulties, the furnace cooled from 2250° to 1800° F in $2\frac{1}{2}$ hr with group 25 rather than $6\frac{1}{2}$ hr, as desired. To compensate for this, the blades in group 25 were held in the furnace at 1800° F for an additional 4 hr before air cooling.)

Figure 19. - Microstructure of cast HS-21 turbine blades after solution treating 1 hour at 2250° F, furnace cooling over $6\frac{1}{2}$ hours to 1800° F, air cooling to room temperature, and aging 72 hours at 1500° F (group 19). Electrolytically etched in 5 percent aqua regia.

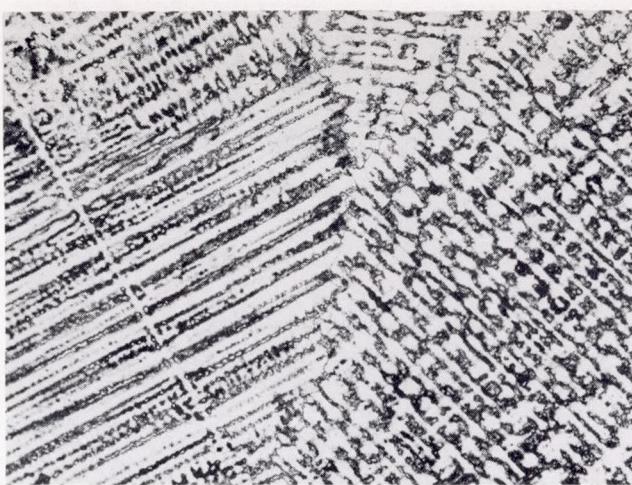
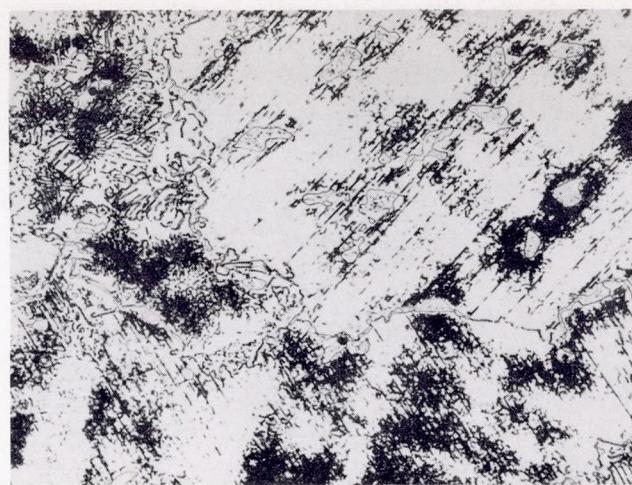
Figure 21. - Microstructure of cast HS-21 blade operated 77.8 hours at rated speed without previous heat treatment.
Electrolytically etched in 5 percent aqua regia.

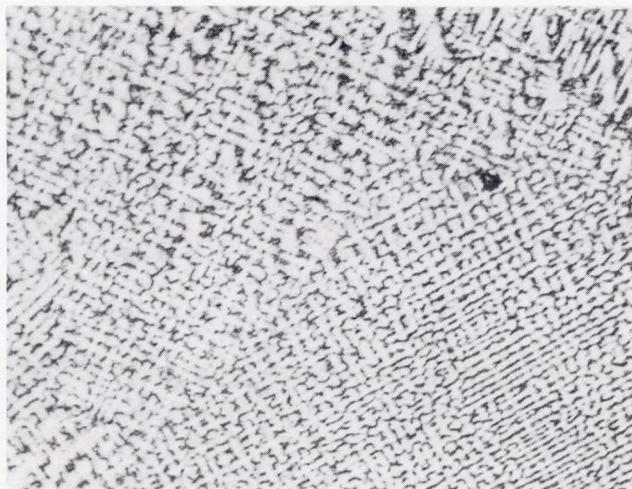
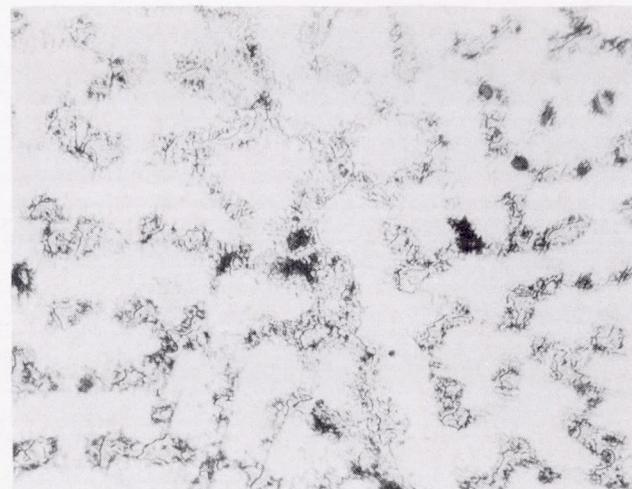
Aging during engine operation. - Extensive aging during operation in the turbine wheel occurred in the case of as-cast blades (groups 1 and 4). The scattered precipitate which formed about the primary carbides during engine operation is shown in figure 21. This figure should be compared with figures 10 and 11, which show the structure of the as-cast blades before operation. The amount of the scattered precipitate increased with the time of operation. Pearlitic precipitation at grain boundaries which was present before operation is also shown in figure 21. The structure of the as-cast blades after operation is similar to that produced by aging alone at 1500° F (groups 5 and 6, fig. 15(a)). Precipitation during engine operation was less for blades which had been aged 48 hours at 1500° F prior to operation (groups 5 and 6, fig. 15(a); group 7, fig. 15(b)). This was true whether the aging was done on the cast blades (fig. 22) or was preceded by solution treatment (figs. 23 and 24).

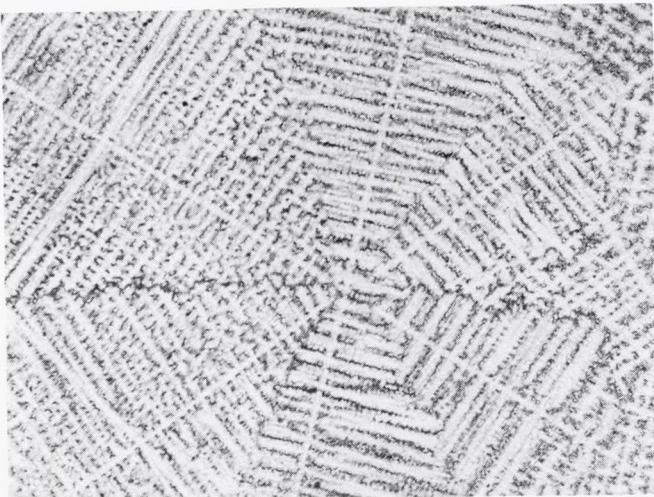
Figure 23. - Microstructure of cast HS-21 turbine blade solution treated 1/2 hour at 2150° F, air cooled, and aged 48 hours at 1500° F after operation for 196.13 hours at rated speed (group 3). Electrolytically etched in 5 percent aqua regia.

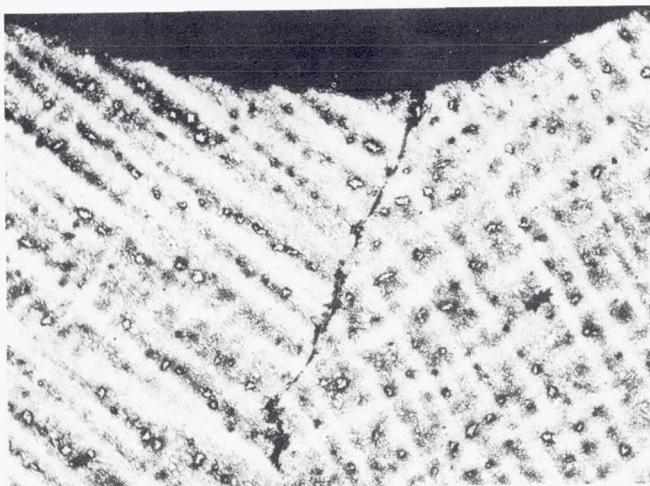
Figure 24. - Microstructure of cast HS-21 turbine blade solution treated 24 hours at 2250° F, air cooled, and aged 48 hours at 1500° F after operation 60.75 hours at rated speed (group 18). Electrolytically etched in 5 percent aqua regia.

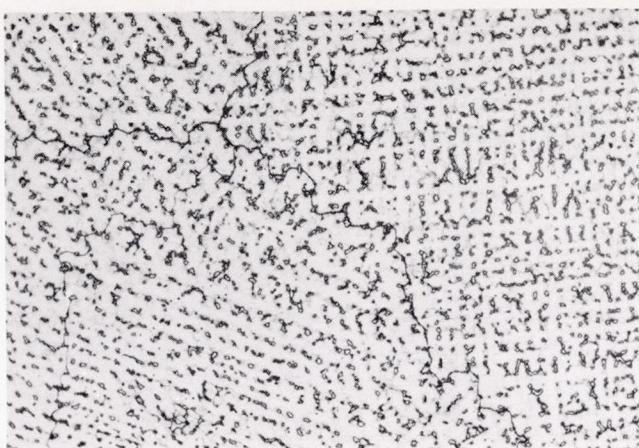
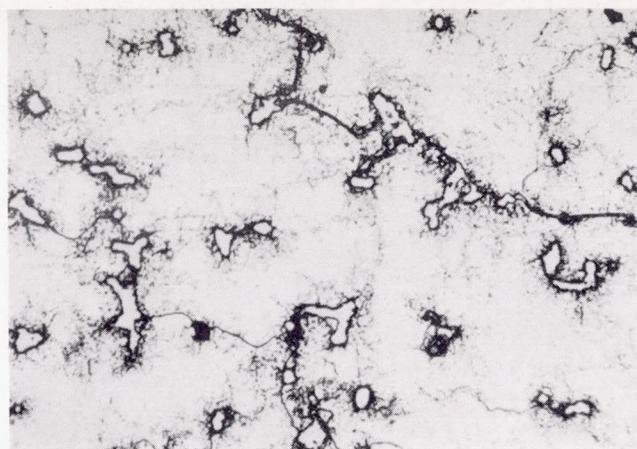
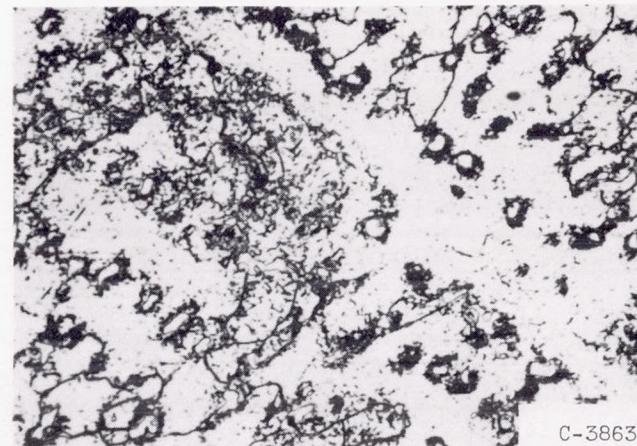
(a) 9.1-Hour operation at rated speed.

(b) 70.2-Hour operation at rated speed.

Figure 25. - Microstructure of cast HS-21 turbine blade solution treated 4 hours at 2050° F, air cooled, and aged 48 hours at 1200° F after operation in engine (group 11). Electrolytically etched in 5 percent aqua regia.

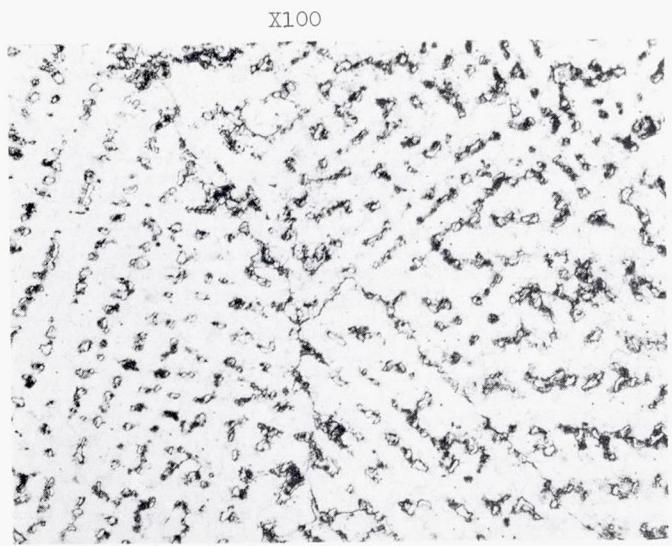
Blades that had been solution treated did not undergo any appreciable changes in microstructure during aging at 1200° F. These blades showed essentially solution-treated structures corresponding to the degree of solution treatment given them. Precipitation did occur under the operating conditions, but not as rapidly as might have been expected. The early failures in such groups of blades frequently showed little precipitation, even after 9.1 hours of operation as shown in figure 25(a) (first failure in group 11). Continued operation increased the precipitation, as shown in the last blade failure of this group (fig. 25(b)). The effect of increasing the time and temperature of solution treatment is seen by comparing figures 25(b), 26, and 27. All these blades were aged at 1200° F after solution treatment, and all were operated in the engine for comparable times. The greater the amount of solution treatment, the more widely distributed is the precipitation which occurs during engine operation. The dark spots in these photomicrographs are areas in which eutectic melting occurred. Melting of this nature may have decreased the operating life from that which might have otherwise been obtained.

Figure 26. - Microstructure of cast HS-21 turbine blade solution treated 24 hours at 2050° F, air cooled, and aged 48 hours at 1200° F after operation 68.4 hours at rated speed (group 12). Electrolytically etched in 5 percent aqua regia.

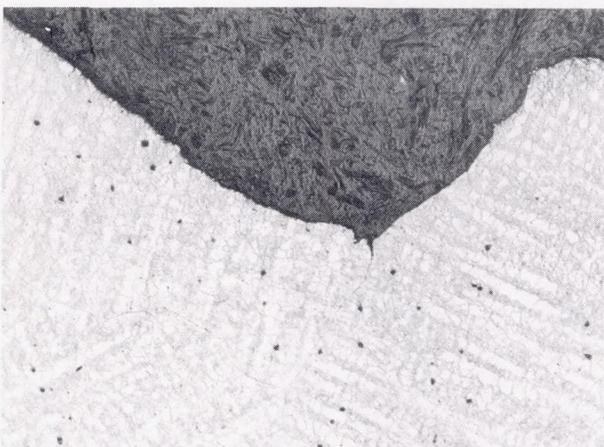
Blade-failure mechanisms. - The majority of blades appeared to fail by a stress-rupture mechanism. Many blades were removed because of a large number of stress-rupture cracks in the airfoil, usually in a zone from $1\frac{1}{2}$ to $2\frac{1}{2}$ inches above the base. Figures 28 and 29 show the fractured edge of several blades which failed in a typical, jagged manner through the grain boundaries. Figure 30 shows a crack in a section just below a fracture edge. Eutectic melting along grain boundaries might contribute to these cracks when high solution-treating temperatures were used. Only a small number of blades had some of the characteristics of fatigue failures.

Figure 28. - Fracture of blade from group 14. Electrolytically etched in 5 percent aqua regia.

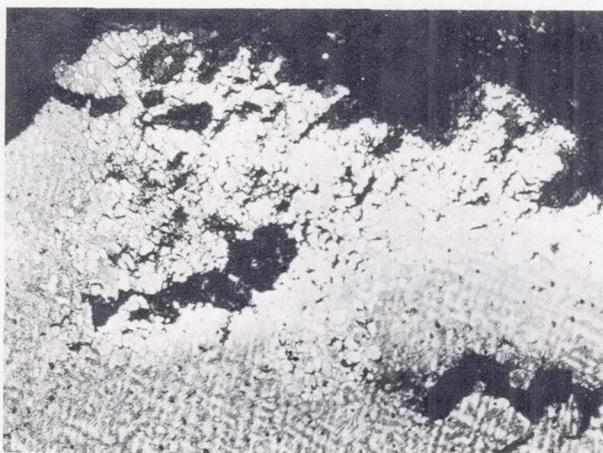
Figure 29. - Fracture of blade from group 8. Electrolytically etched in 5 percent aqua regia.

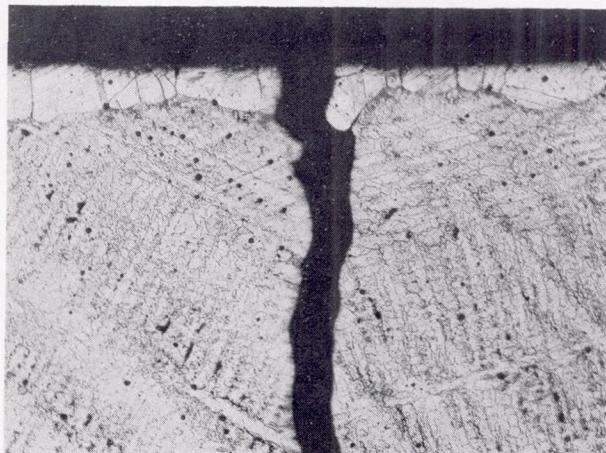
Figure 30. - Crack below fractured edge of blade from group 13. Electrolytically etched in 5 percent aqua regia.

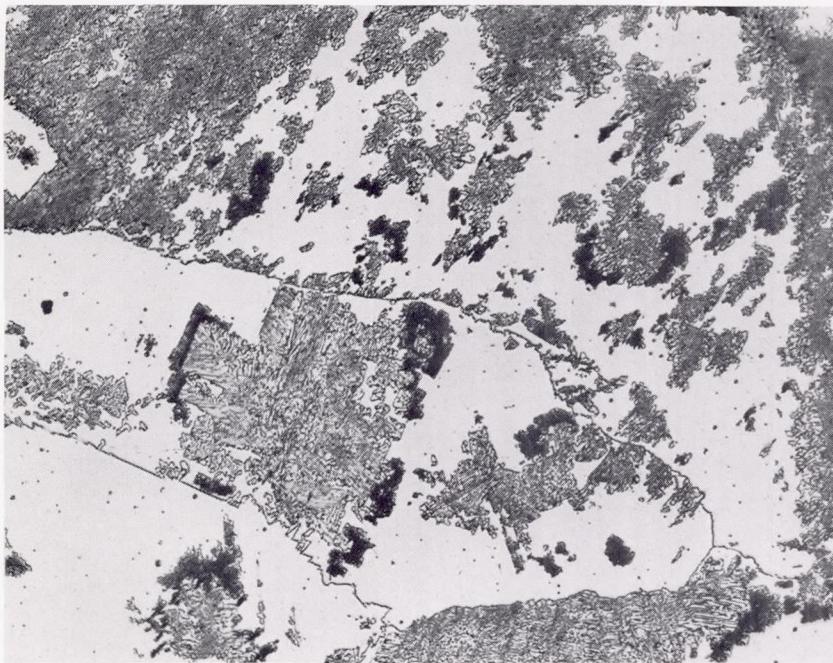
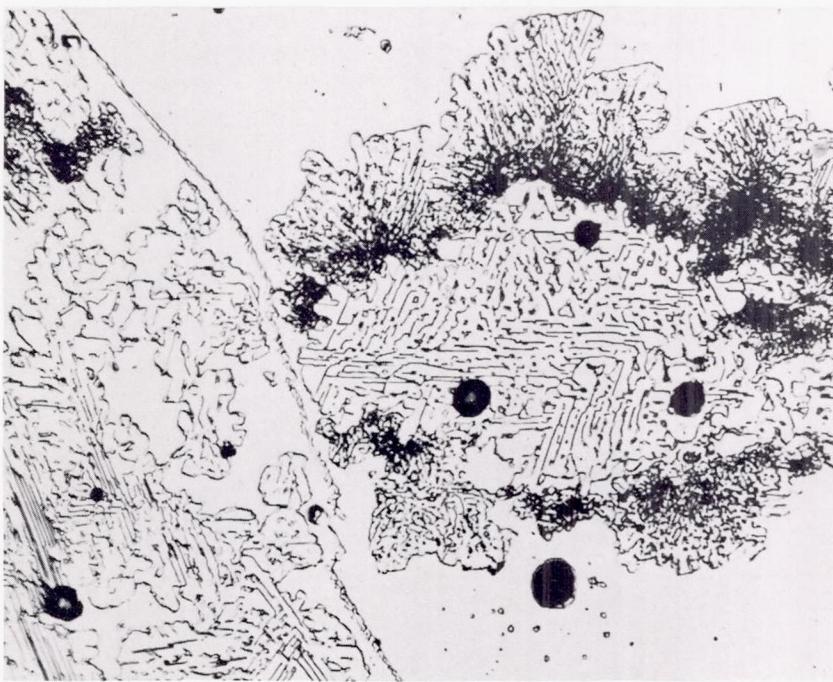
The heat treatment given groups 24 and 25, which had increased the life of small cast turbosupercharger blades by as much as 200 percent, (ref. 3) reduced the performance of the large turbine blades used in this investigation. This was due to differences in the carbide formations in the two sizes of parts. The interdendritic carbides in the small as-cast blades were in the form of partially spheroidized structures (fig. 31). Because of the fineness of these structures and lack of large interdendritic pools of eutectics, relatively little difficulty in solution treating would be expected. Voids or rosettes resulting from melting were found in the smaller blades, but they were much smaller than those found in the large blades of the present investigation. Also, the structure of the small blades after heat treatment contained a finer and more uniform dispersion of carbides than did the large blades given the same treatment (see fig. 32). Thus, if the structures of the blades in this investigation had been controlled to prevent the formation of large eutectic pools and interdendritic carbides, many of the heat treatments might have substantially improved the engine performance.

Figure 32. - Microstructure of specimens cut from small turbosupercharger blades given heat treatment of reference 3 (1 hr at 2150° F, furnace cooled to 1800° F in 6 hr, air cooled, and aged 72 hr at 1500° F). Electrolytically etched in 5 percent aqua regia.
